1. Project Name: Tau Harbor
2. Date of Inspection: May 23, 2002
3. Inspection Personnel:

## TAU SMALL BOAT HARBOR, AMERICAN SAMOA

### CONDITION OF IMPROVEMENT 30 SEPTEMBER 1993

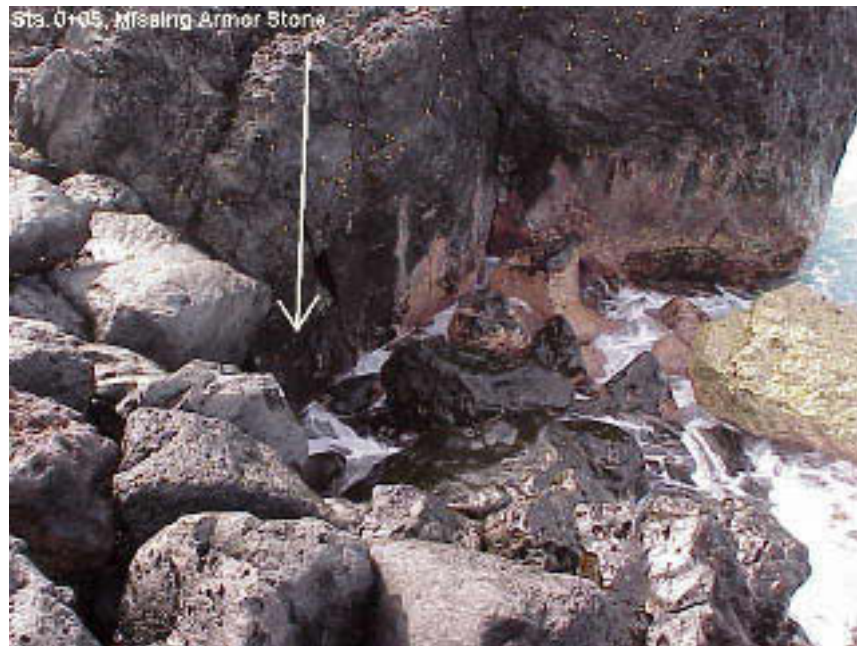
- a. Sta. 0+05, one armor stone missing from toe of revetment (Feb 2001 Photo no change).
- b. Sta. 0+25, Monitor 1 ea. flipped armor stone at the hinge.
- c. Sta. 0+50, 1 ea. cracked armor stone at the crest.

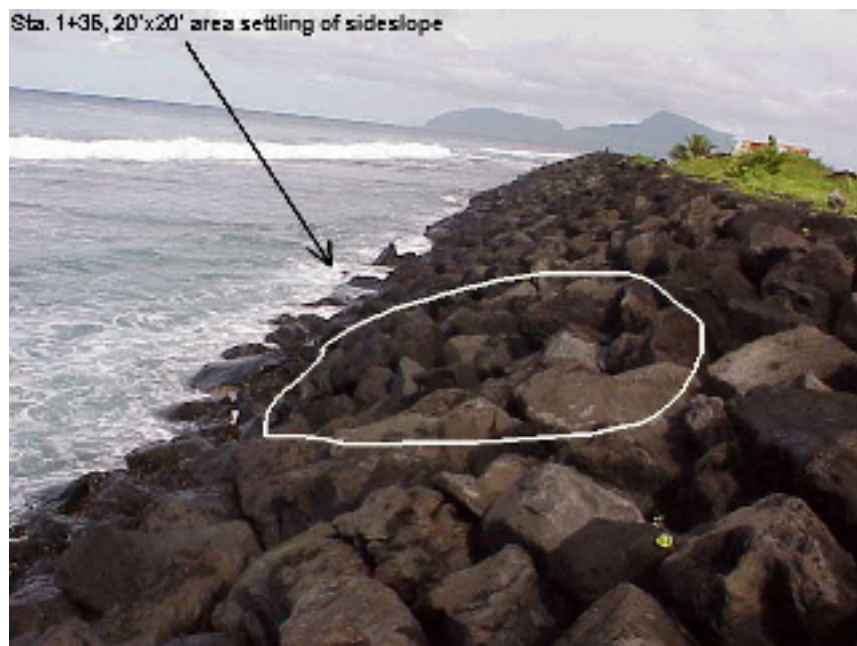
- d. Sta. 1+35, 20'x20' area of settling in armor stone revetment (Feb 2001 Photo no change).
- e. Sta. 1+40, Monitor void, 1 ea. armor stone missing from crest.
- f. Sta. 1+42, Monitor 1 ea. flipped armor stone and settling of the sideslope.

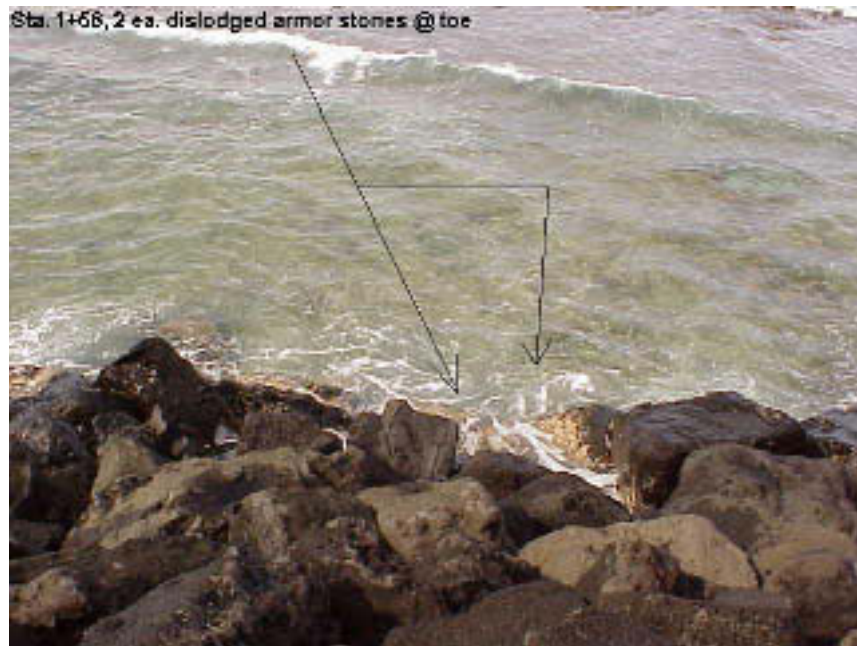
g. Sta. 1+56, two armor stone dislodged at toe (Feb 2001 Photo no change).

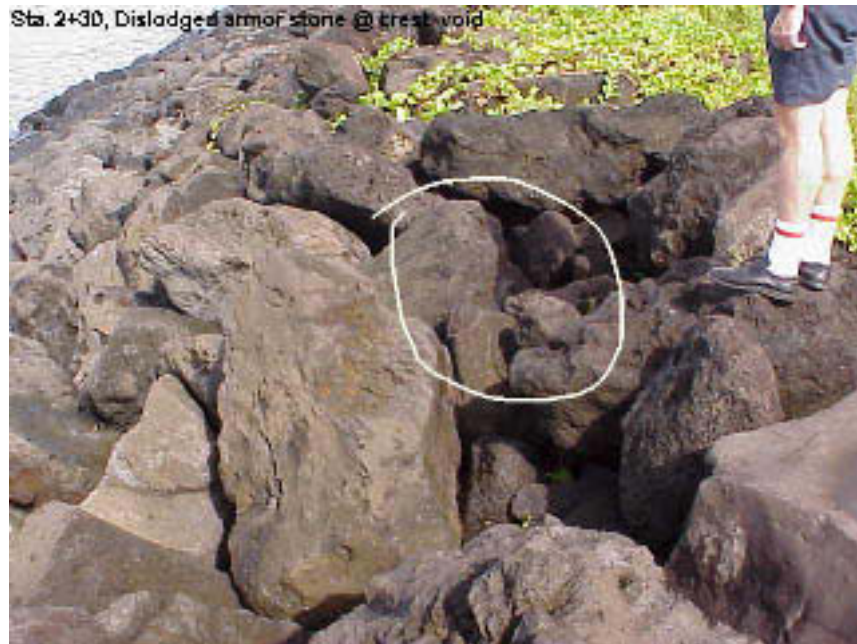
j. Sta. 3+30, Harborside (HS), Void at crest, 1 armor stone missing (Photo Sta. # incorrect), (Feb 2001 Photo no change).

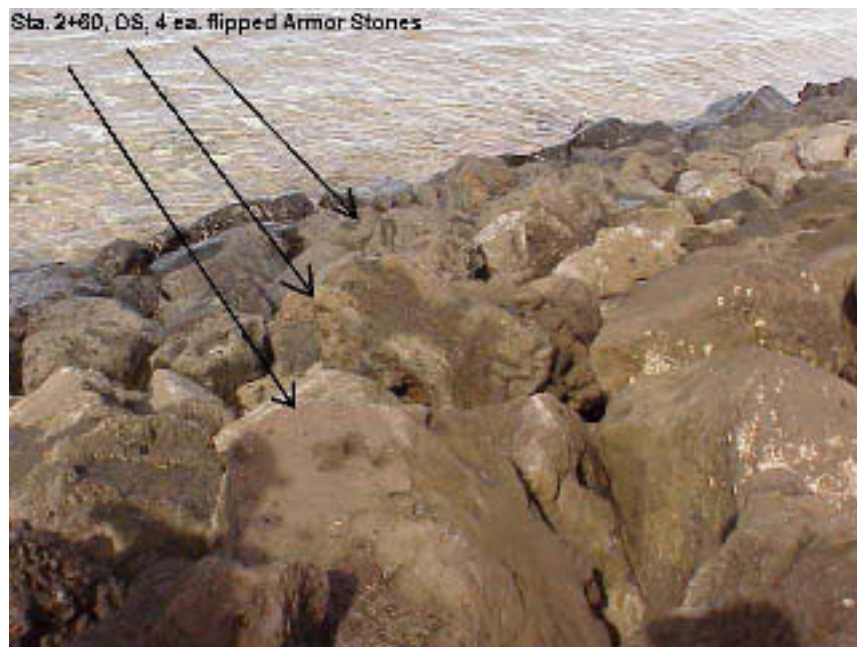
k. Sta. 3+60, minor settling of crest, 4 ea. armor stones "flipped" and void on the sideslope (Photo Sta. # incorrect), (Feb 2001 Photo no change).

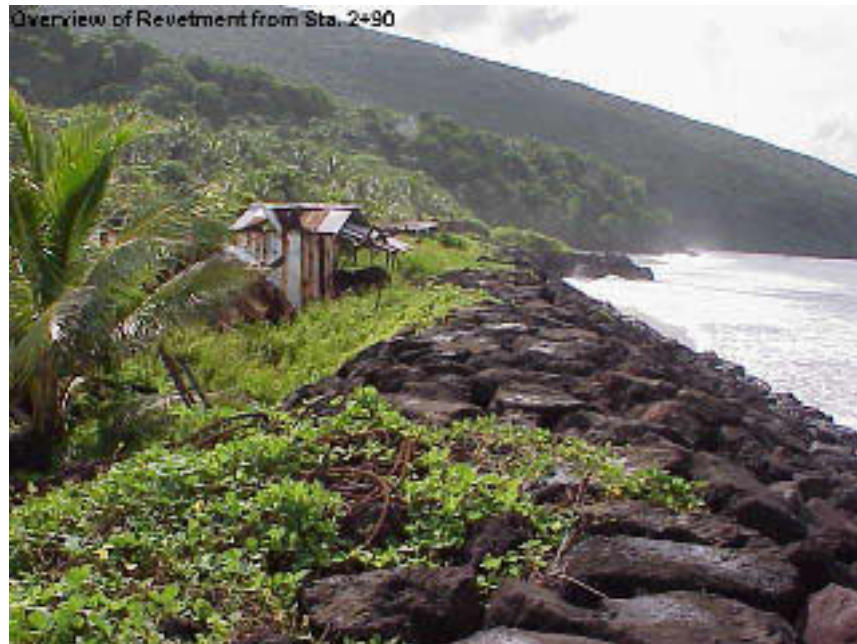
1. Sta. 3+90, OS, remove wire-rope from crest (Photo Sta. # incorrect), (Feb 2001 Photo no change).

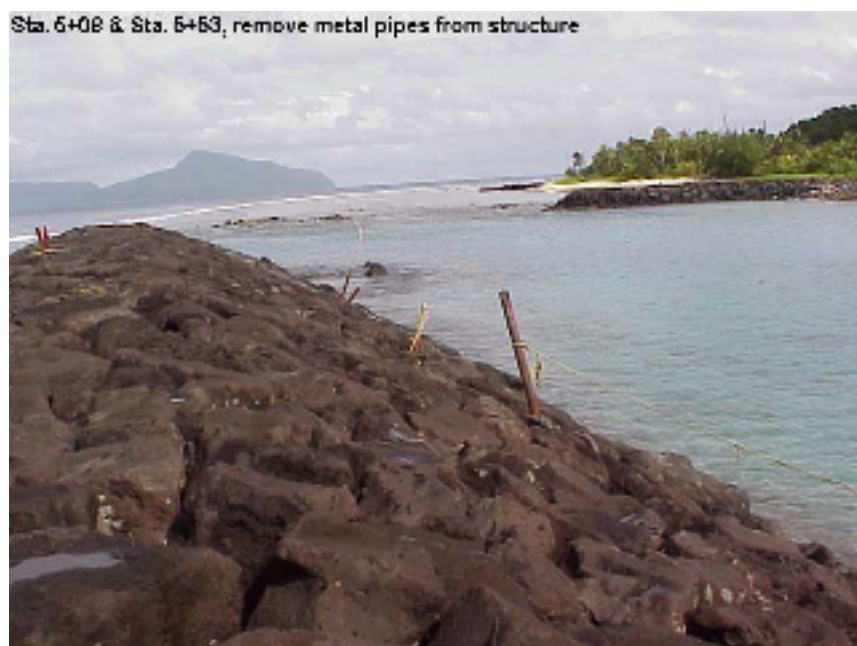
- c. Sta. 5+08 & 5+53, crest and harbor-side remove metal pipes placed between armor stone (used as mooring points) (Feb 2001 Photo no change).

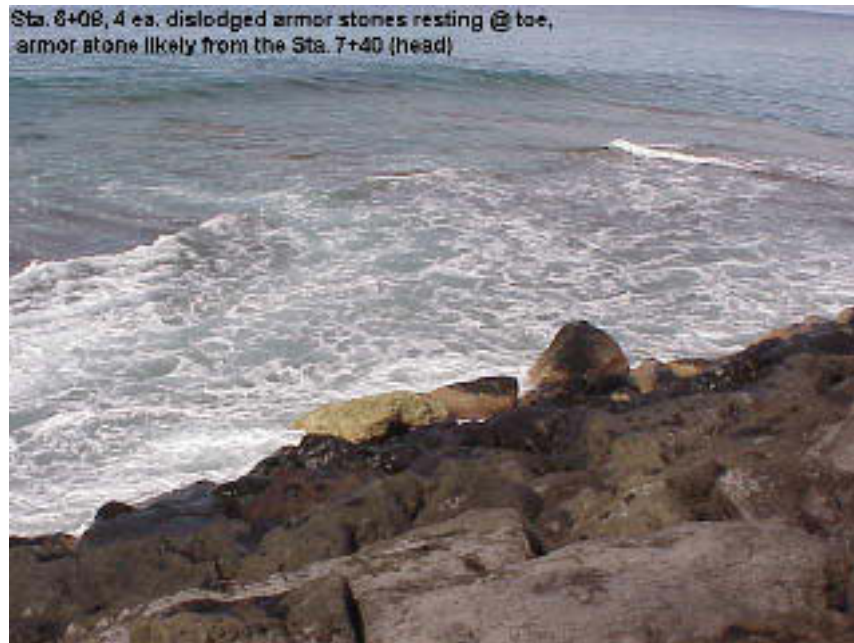
d. Sta. 6+08, OS, four armor stones resting at the toe, dislodged head area (Sta. 7+15, OS). 1 ea. cracked armor stone on crest (Feb 2001 Photo no change).

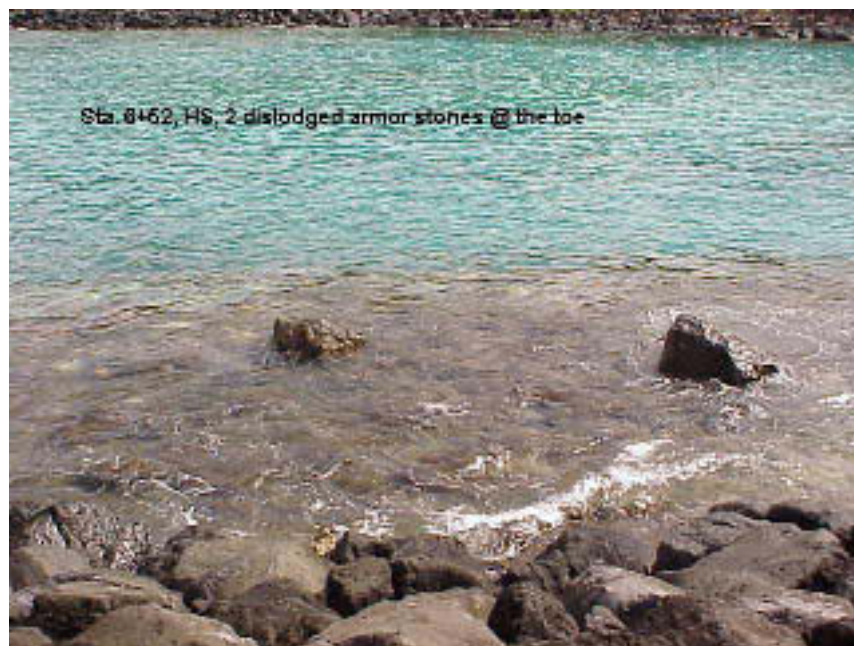
e. Sta. 6+52, HS, dislodged armor stones at toe (Feb 2001 Photo no change).

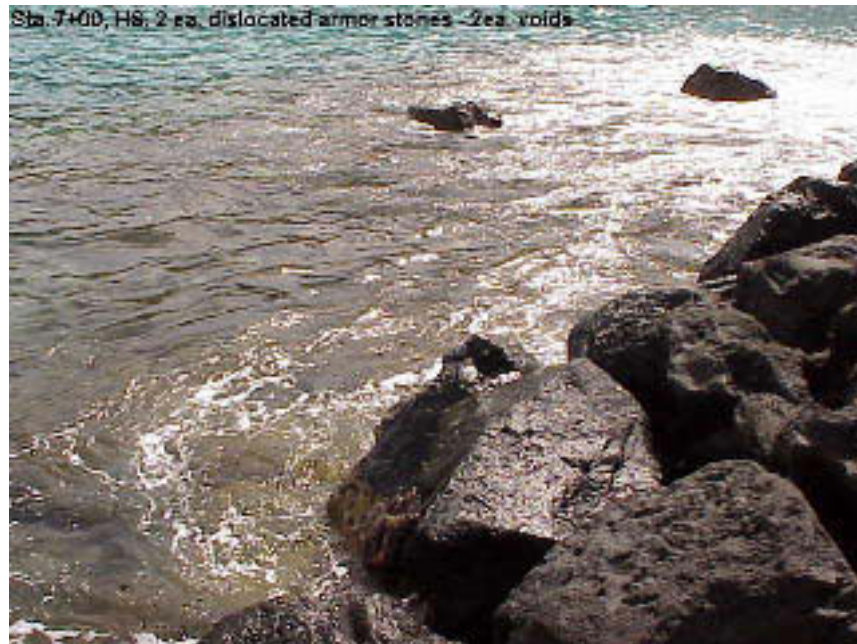
f. Sta. 7+00, HS, head, two voids at toe (Feb 2001 Photo no change).

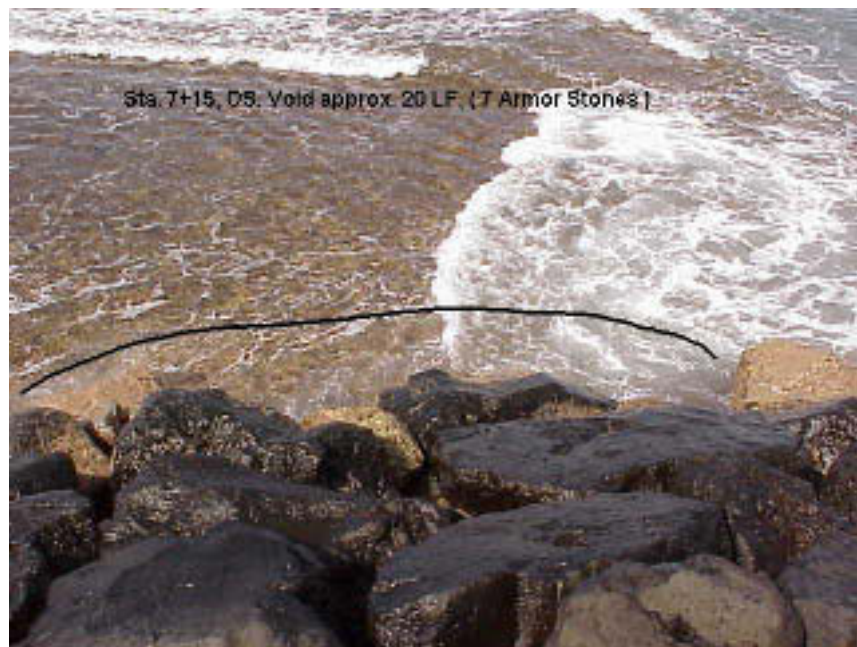
g. Sta. 7+15, OS, 20LF of toe armor stone is missing (Feb 2001 Photo no change).

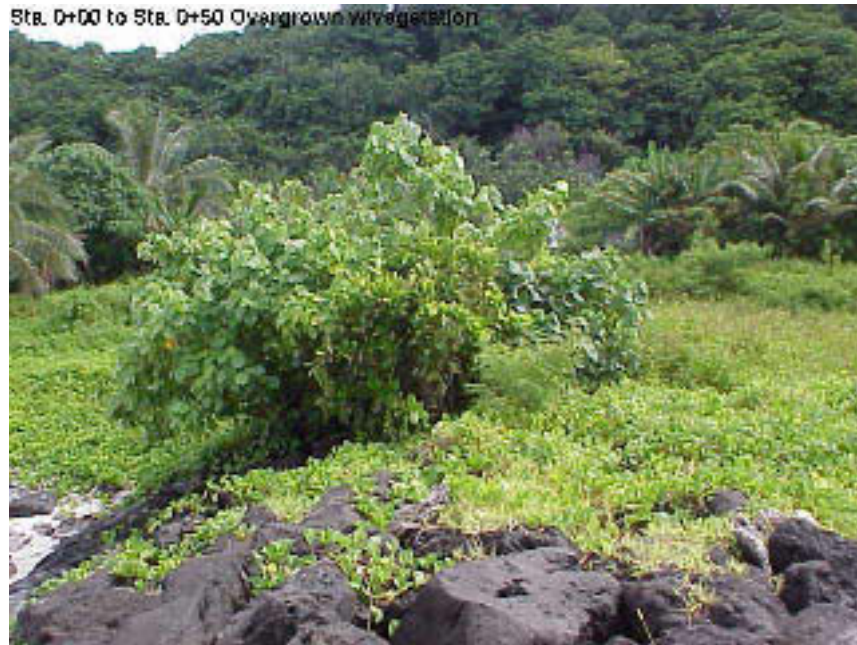
- a. Sta. 0+00, to 0+50, The vegetation continues to creep further onto the root of the structure. (Feb 2001 Photo additional changes).

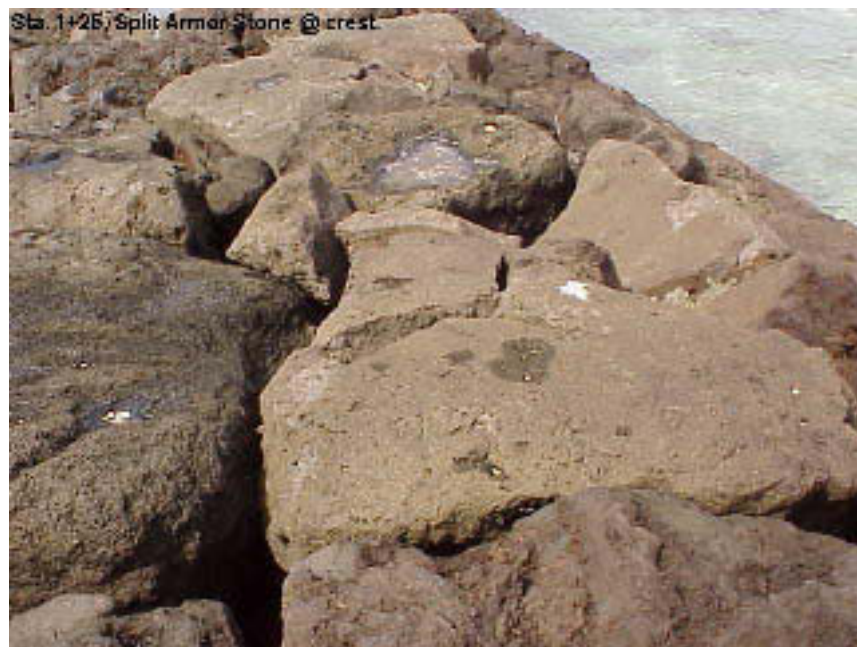
- b. Sta. 1+25, Crest, 1 ea. fractured armor stone at crest (Feb 2001 Photo no change).

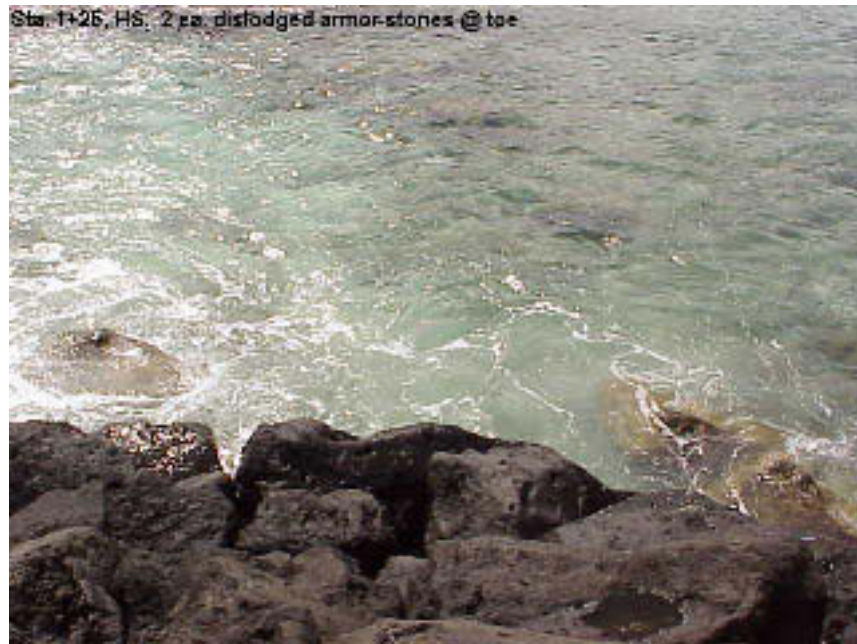
c. Sta. 1+25, two dislodged toe stones, harbor side. (Feb 2001 Photo no change).

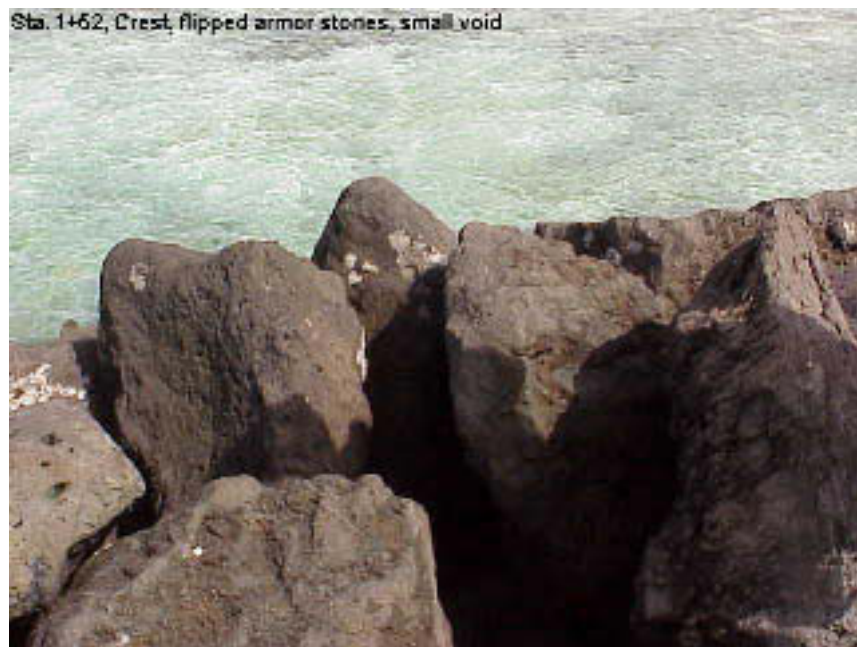
d. Sta. 1+52, three stones twisted at crest (Feb 2001 Photo no change).

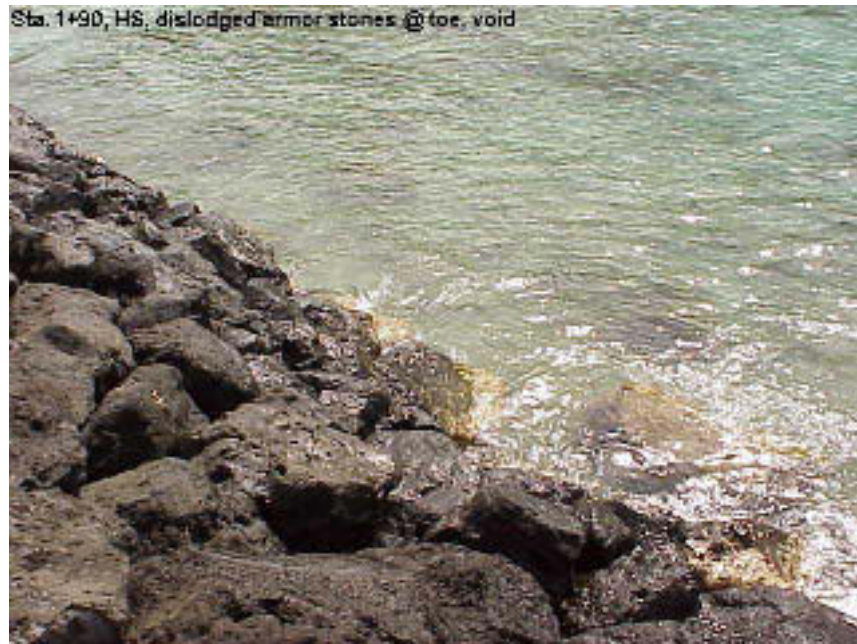
e. Sta. 1+84, HS, Monitor void 1 ea. armor stone dislodged at crest, 1 ea. armor stone dislodged at the toe (Feb 2001 Photo no change).

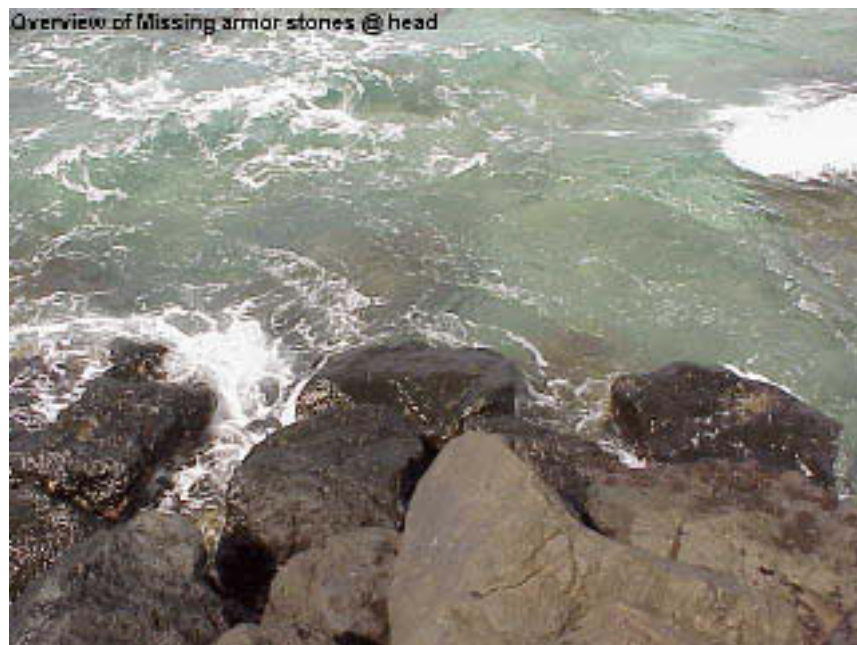
f. Sta. 2+00, Dislodged armor stone at head (Feb 2001 Photo, there were minor changes this inspection).

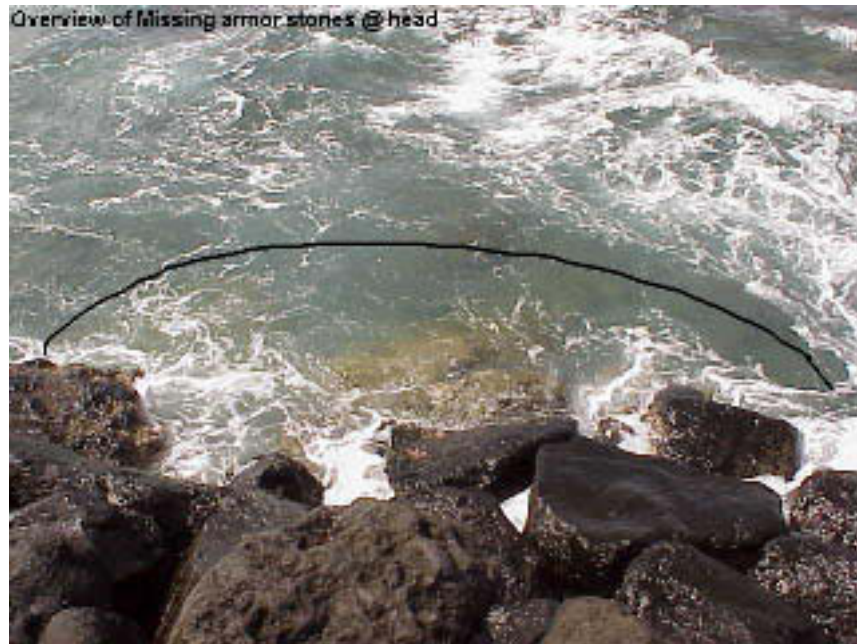
g. Sta. 2+00, Dislodged armor stone at head (Feb 2001 Photo, there were minor changes this inspection).

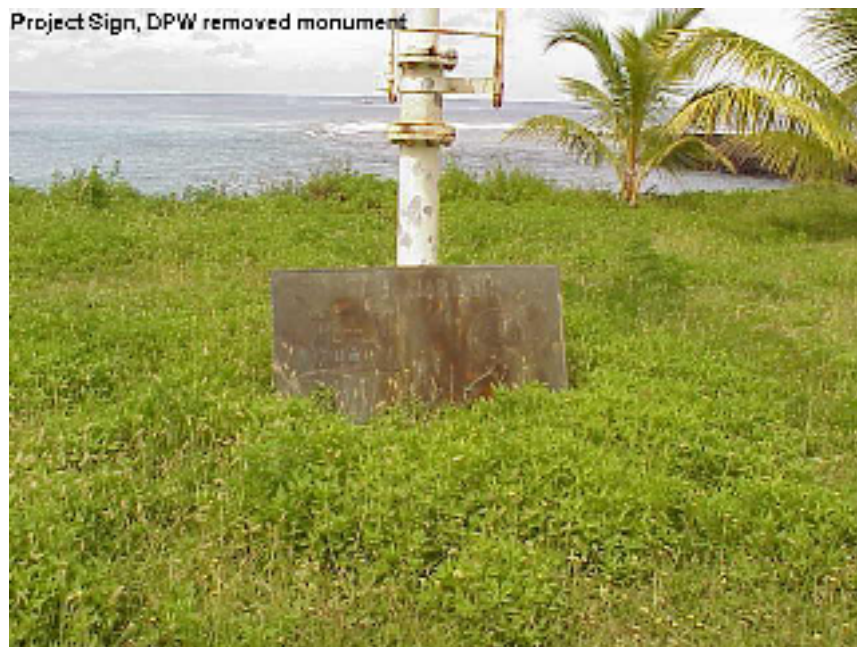
a. The COE project sign is laying near the first range marker. The vegetation now obstructs the sign's view (Feb 2001 Photo). There are deep scratches, gouges, and some graffiti on the sign.
